Procedia Engineering 75 (2014) 45 – 50

International Conference on Materials for Advanced Technologies: Symposium W

**Non-contact measurement techniques for structural health  
monitoring****W.H. Ong, W.K. Chiu\****Department of Mechanical & Aerospace Engineering, Monash University, Wellington Road, Clayton, 3168, Australia***Abstract**

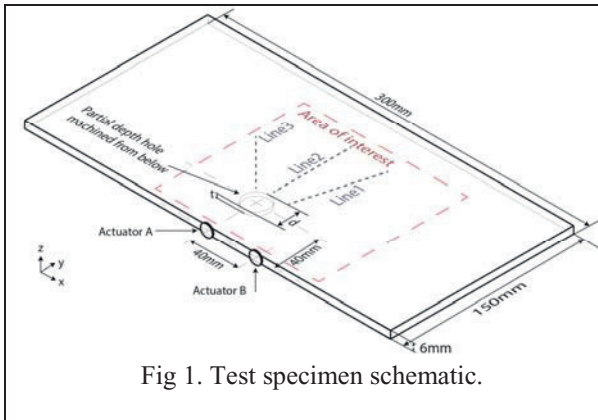
Fig 1. Test specimen schematic.

The test specimens used in this investigation is made from 6 mm thick aluminium. A partial depth hole is machined on one side of the test plate as shown in Fig 1. A 20 mm diameter partial depth hole was used to simulate a non-surface penetrating defect. The depth of the defect was firstly set at 0.25h (1.5 mm) and was increased to 0.5h (3 mm) and 0.75h (4.5 mm), where h=6 mm (see Fig 1).

Two 10 mm piezoceramic (PZT) actuators (Actuators A and B) were bonded to the edge of the specimen as shown in Fig 1. For the purpose of this paper, only the results from Actuator A are presented. These PZT actuators were excited independently of each other and in a given set of experiment only one of them was used. A 5 cycle Hanning windowed sinusoidal tone burst with a centre frequency of 300 kHz was used to excite these PZT actuators thereby initiating a stress wave that propagated in the test specimen.

Fig 1 also indicates the side of the flat plate that was scanned during the experiment. The coordinate system used to define the direction of measurement is also shown in Figure 1. The in-plane components are defined by the x- and y-direction components, whilst the z-direction defines the out-of-plane component. Prior to the introduction of the non-surface penetrating defect, the undamaged specimen was scanned to obtain a baseline. It was then removed from the test rig to introduce the desire partial depth damage and re-position on the test rig for re-scanning. The damage was progressive increased following each scan. The scattering of the velocity field from the inclusion of damage can then be visualised by calculating the subtraction of the damaged velocity field from the defect free baseline velocity field for each time step:

The test plate without this damage was firstly scanned to obtain the baseline. To understand the modal content of the velocity fields, the spatial and temporal data were transformed to wavenumber and frequency as shown in Figures 3(a) – 3(c) taken along Line 1 (see Fig 1). Against each of these plots, the analytical Ao, So and the SHo modes are included for comparison. It is evident from these plots that the excited stress wave comprises mainly the So and the SHo modes. Note that the SHo mode could only be measured with the in-plane velocity measurement.

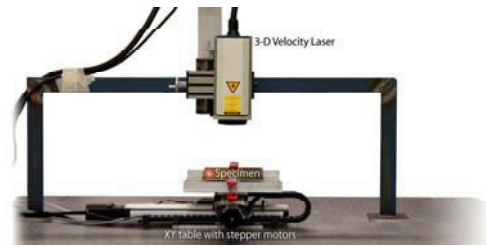
Fig 2. Experimental test setup.

A computer controlled laser vibrometry rig pictured in Figure 2 was developed at Monash University for use in this investigation (see also [1]). A Parker Automation 404XE Electromechanical Positioning System with LV233 stepper motors was used to position the specimen. The stepper motors, capable of a resolution of 5000 steps per millimetre, enabled accurate and consistent positioning of the mounted specimen. Custom software was developed in MATLAB to synchronise positioning with signal generation and data acquisition.

Lamb wave responses of the plate were sensed using a three axis laser vibrometer. A Polytec CLV 3D sensor head with left, right and top beams, was positioned and focused to measure three components of velocity ( $V_L$ ,  $V_R$  and  $V_T$ ) of the specimen at any given position. The 1.5 MHz modified CLV-M030.B decoder module output a voltage directly proportional to the surface velocity with a factor of 5 mm/s/V. The velocity signals were later converted to their orthogonal components using the supplied equations (Polytec [7]), where the angle between the optical axis and the top laser beam is  $12^\circ$  with a 160 mm focal length lens. The test setup is shown in Fig 2. Data acquisition was performed with a National Instruments PCI-6115 board and BNC-2110 block at 10 MHz and stored in the controlling computer. Input capture from the laser was hardware triggered by the rising edge of the excitation signal. This was essential for ensemble averaging and synchronisation of spatially varying data. In this case, 16 time series averages were performed at each scan location to enhance the signal-to-noise ratio for a series length of 1 millisecond. The excitation signals were amplified from the 1 Vp-p 4MHz output to 73 Vp-p with a Krohn-Hite Model 7602 Wideband Power Amplifier.
